# Honda Accord LX Broadside Collision With a Narrow Fixed-Object: FOIL Test Number 97S006

PUBLICATION NO. FHWA-RD-98-011

JANUARY 1998

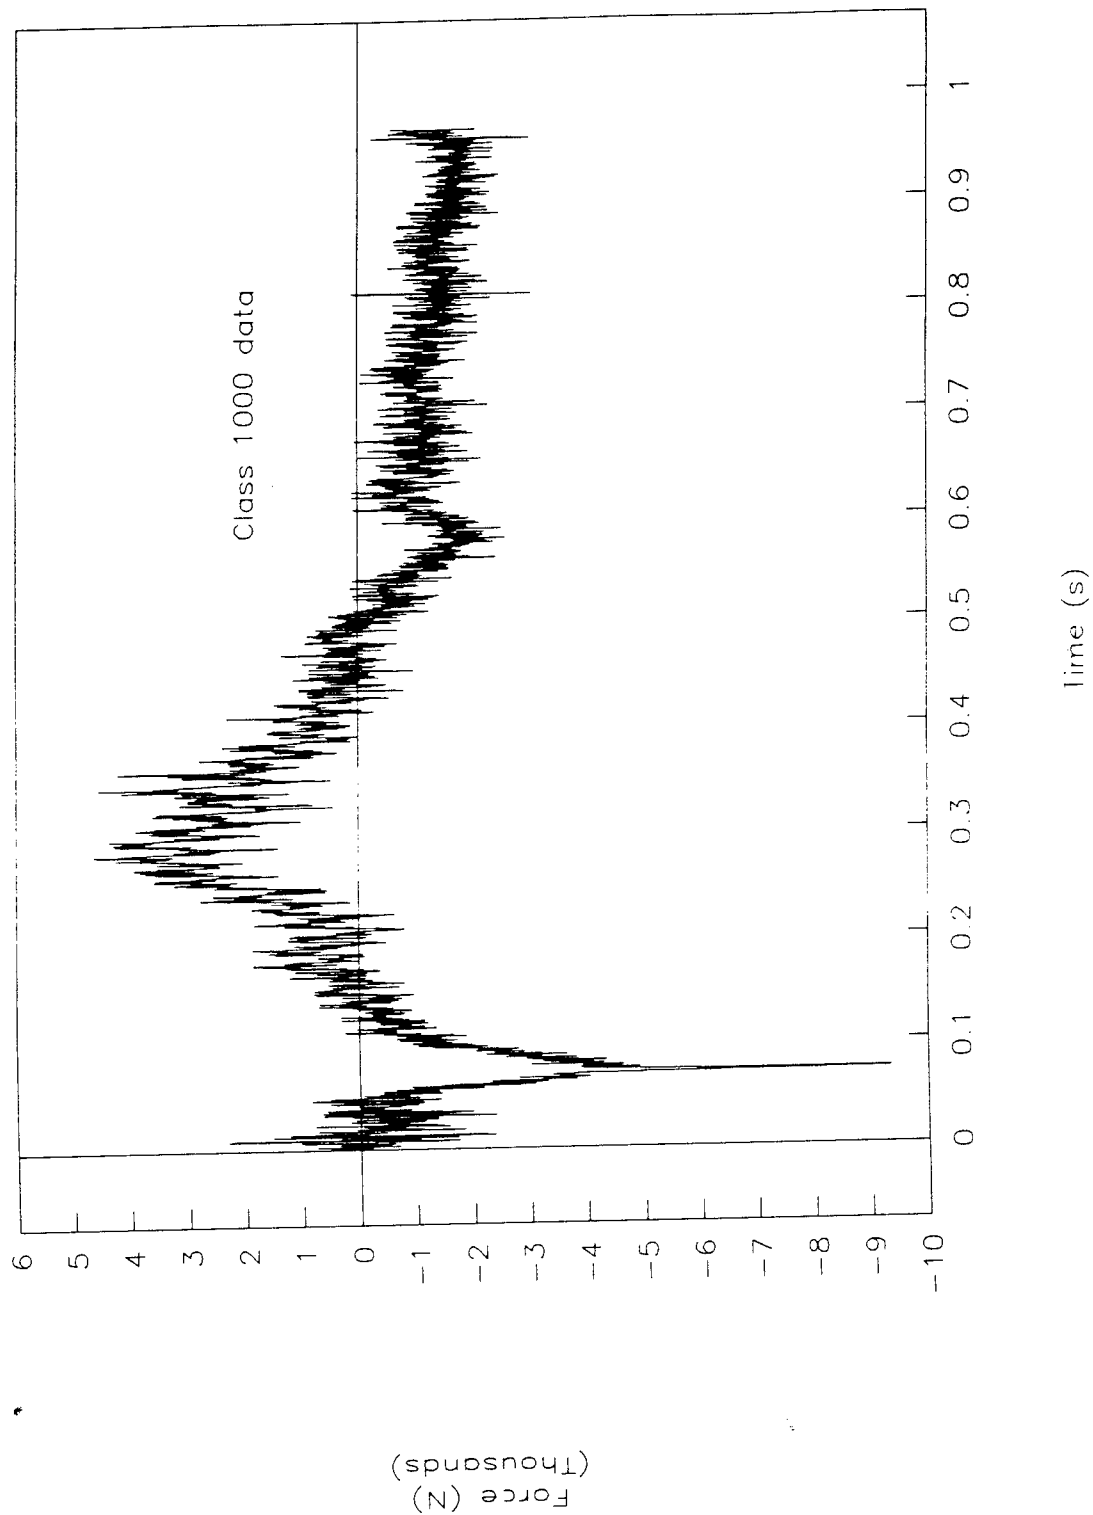
Figure 43. Rigid pole, force vs. time, upper-middle face lower load cell, test 97S006.

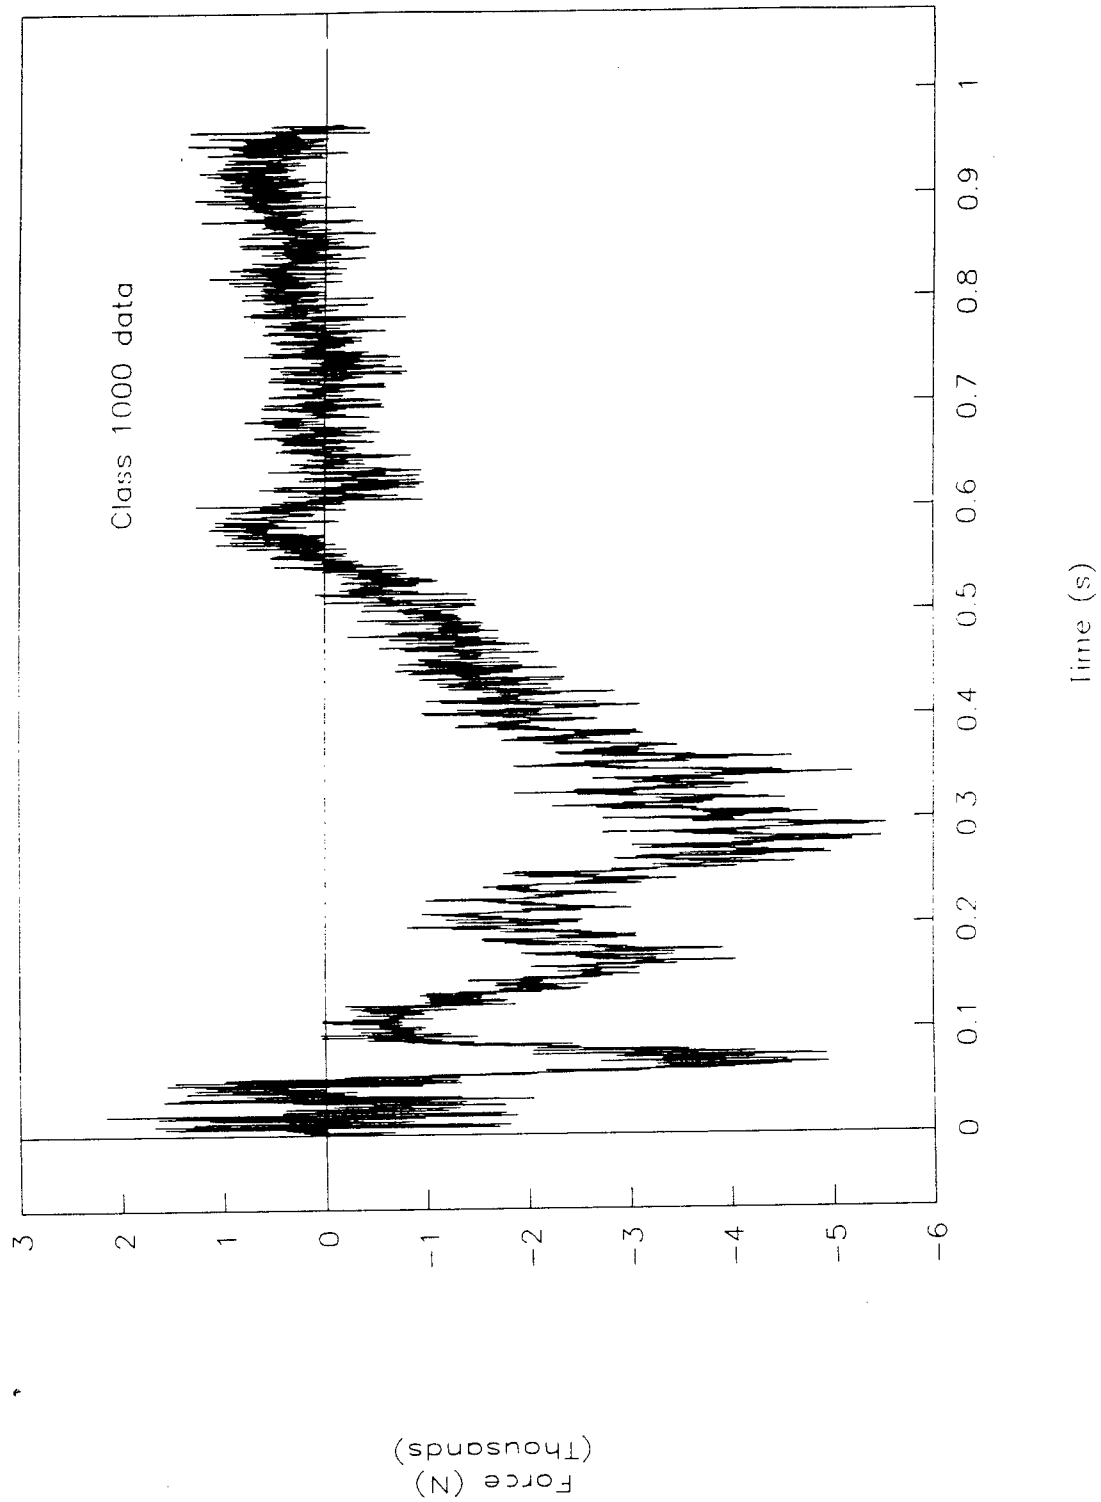
Figure 44. Rigid pole, force vs. time, upper-middle face upper load cell, test 97S006.

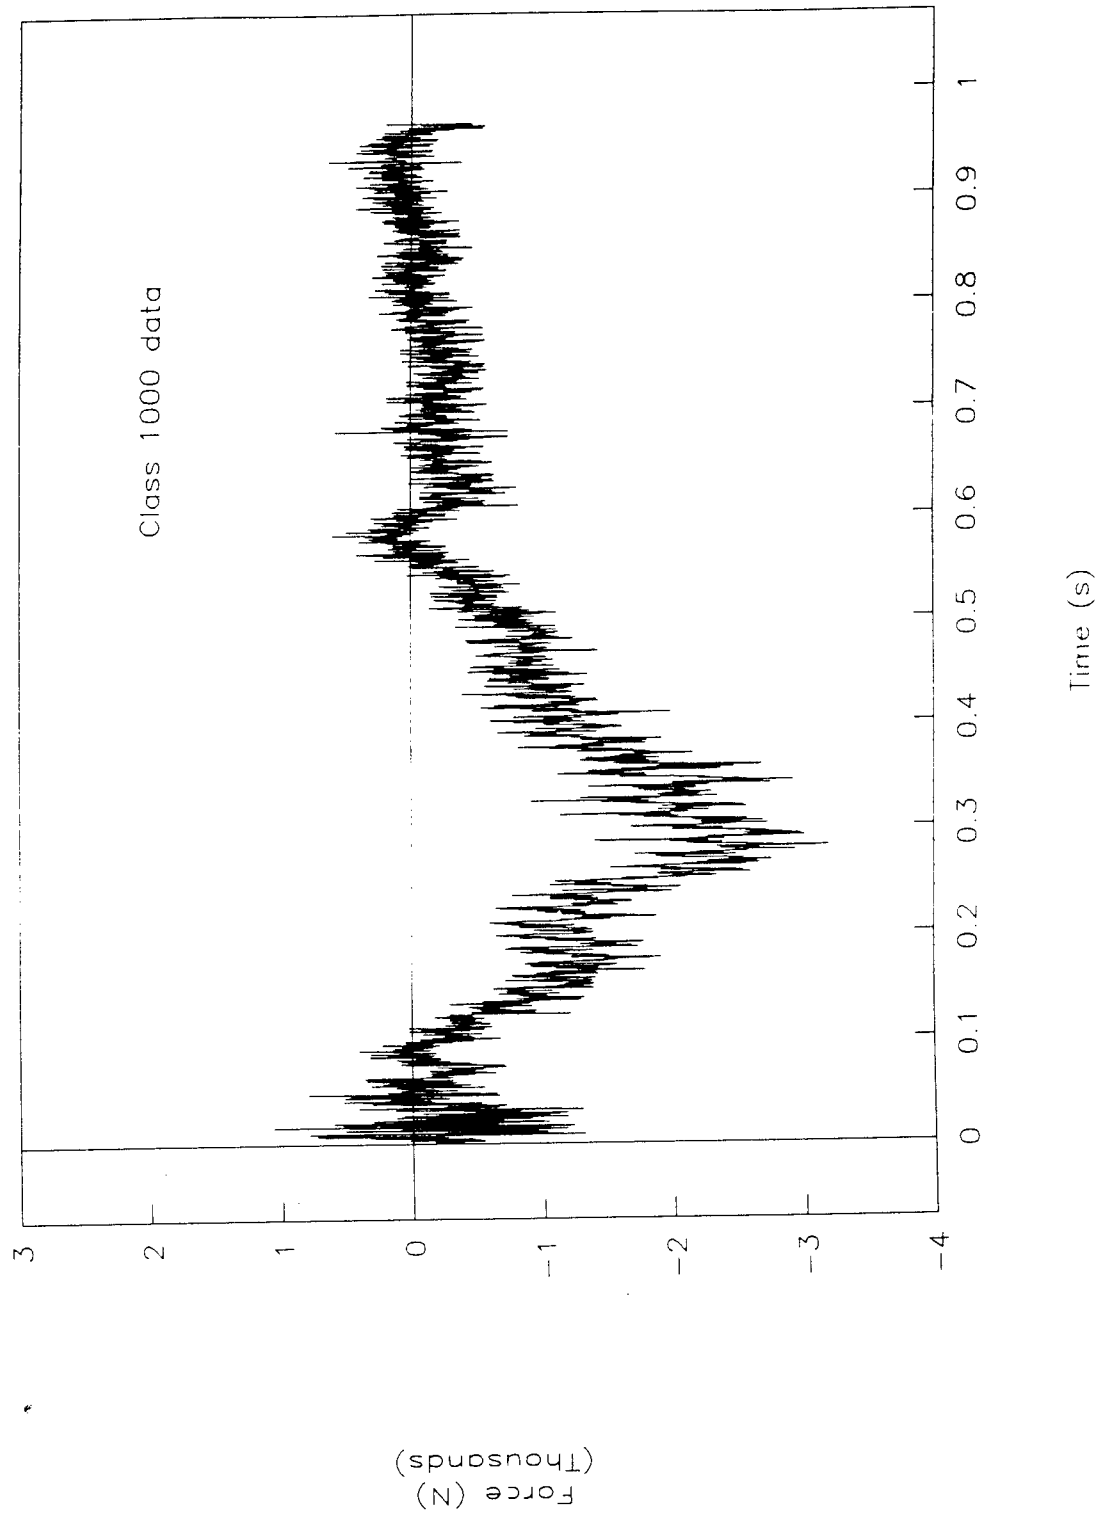
Figure 45. Rigid pole, force vs. time, upper face lower load cell, test 97S006.

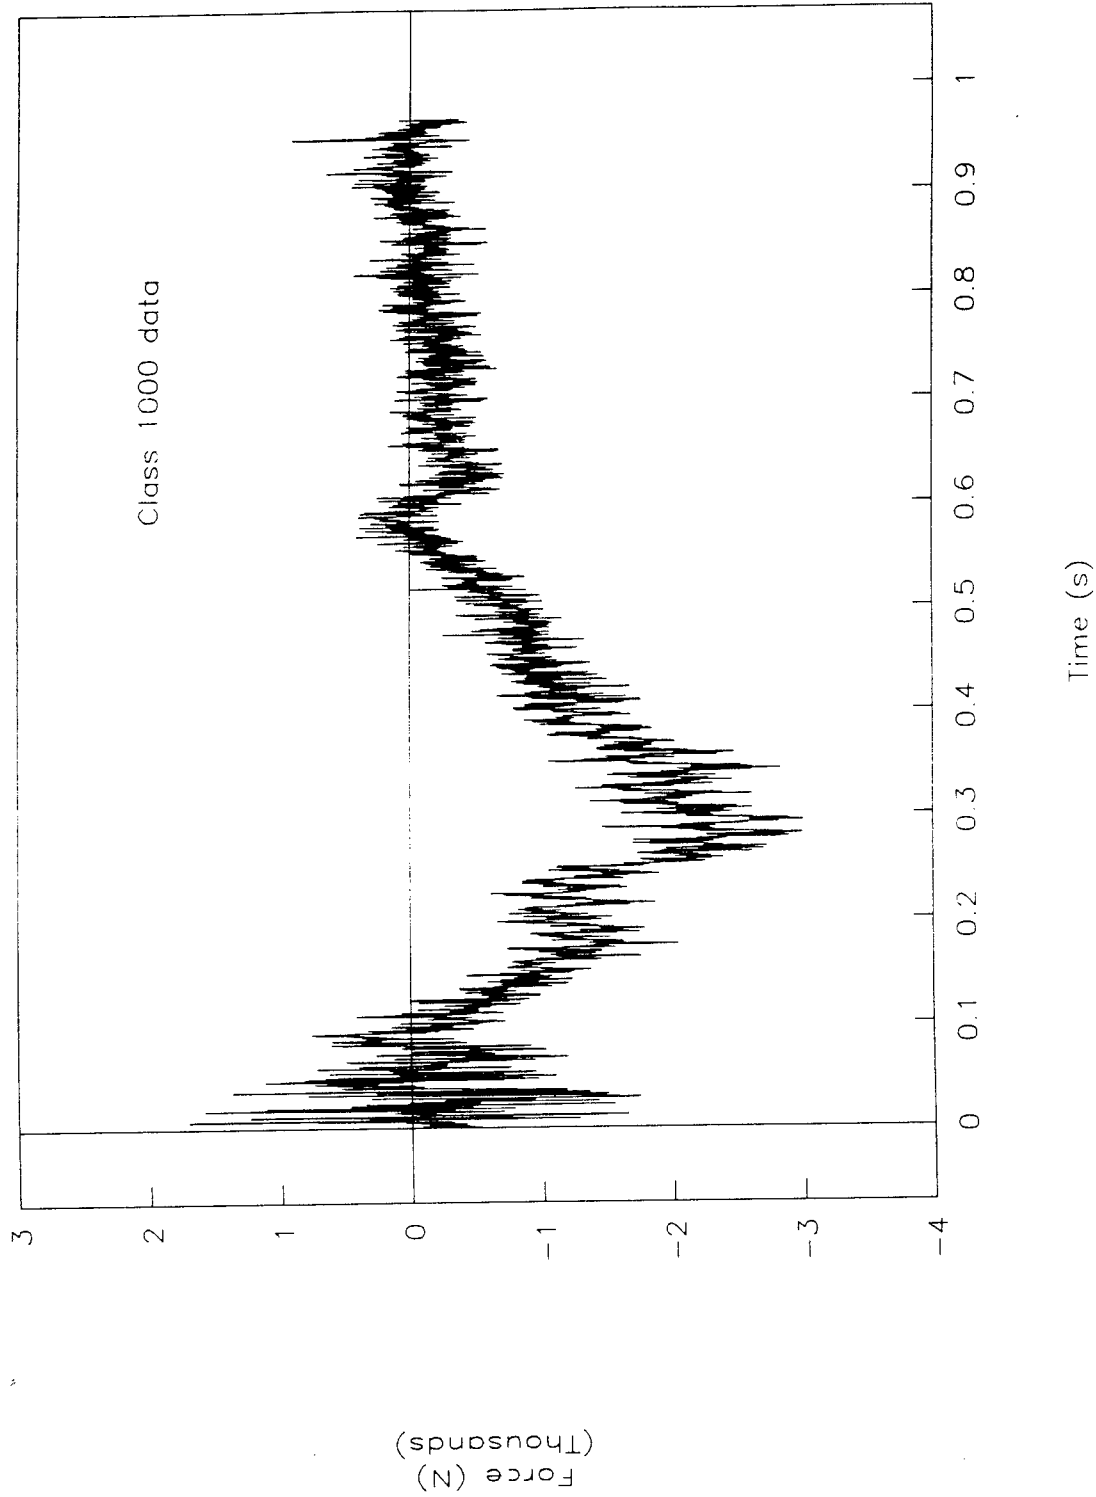
Figure 46. Rigid pole, force vs. time, upper face upper load cell, test 97S006.
